**DEPARTMENT OF TRANSPORTATION****DIVISION OF ENGINEERING SERVICES**

Quality Assurance and Source Inspection

Contract #: 04-0120F4Cty: SF/ALA Rte: 80 PM: 13.2/13.9File #: 69.28**WELDING INSPECTION REPORT****Resident Engineer:** Pursell, Gary**Address:** 333 Burma Road**City:** Oakland, CA 94607**Report No:** WIR-003450**Date Inspected:** 27-Jul-2008**Project Name:** SAS Superstructure**OSM Arrival Time:** 700**Prime Contractor:** American Bridge/Fluor Enterprises, a JV**OSM Departure Time:** 1530**Contractor:** Zhenhua Port Machinery Company, Ltd (ZPMC), Changxing Island **Location:** Shanghai, China**CWI Name:** Sun Wei, Ye Yong Jun**CWI Present:** Yes No**Inspected CWI report:** Yes No N/A**Rod Oven in Use:** Yes No N/A**Electrode to specification:** Yes No N/A**Weld Procedures Followed:** Yes No N/A**Qualified Welders:** Yes No N/A**Verified Joint Fit-up:** Yes No N/A**Approved Drawings:** Yes No N/A**Approved WPS:** Yes No N/A**Delayed / Cancelled:** Yes No N/A**Bridge No:** 34-0006**Component:** Tower & OBG**Summary of Items Observed:**

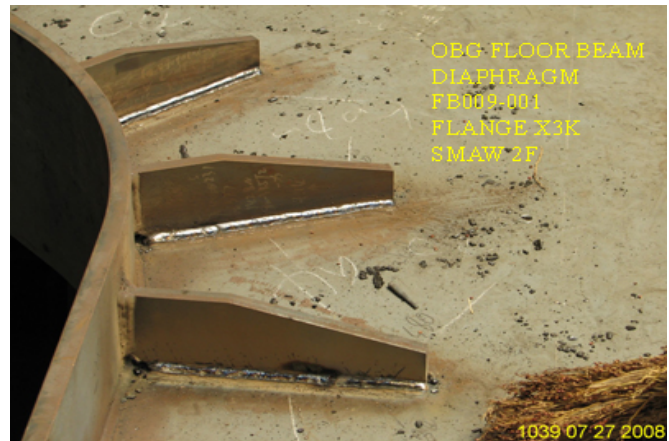
(Horizontal Fillet) Position with ZPMC WPS WPS-B-P-2112, to weld Stiffeners piece marks X3K and X3N to Floor Beam Diaphragm Sub-Assembly FB009-001. The QA Inspector randomly observed ZPMC CWI Hu Wei Qing monitoring weld parameters. The weld parameters appeared to comply with contract requirements. The attached photograph provides additional detail.
